PROPERTY INSPECTION REPORT

123 Main Street
Anytown NJ 11111

Tuesday, 3/3/2009

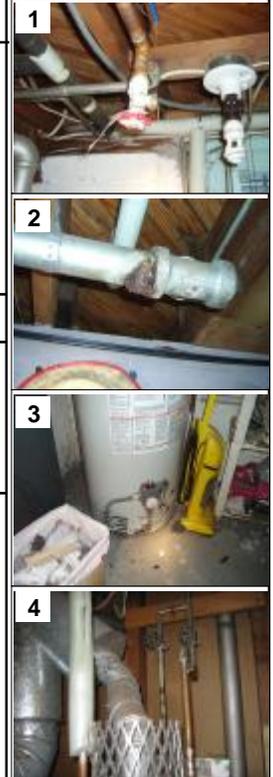
- Two active leaks were found at pipes at ceiling of basement. One leak was to the right of the boiler and the other was above the washer/dryer. Have repaired by a plumber. - (See Photos 1 & 2)
- A slow drip at water heater drain valve noted. Have repaired by a plumber. - (See Photo 3)
- The water heater has no jumper cable between the hot and cold water piping. Add electrical jumper cable for proper bonding. - (See Photo 4)
