# PROPERTY INSPECTION REPORT

**123 Main Street**  
**Anytown NJ 11111**

**Tuesday, 3/3/2009**

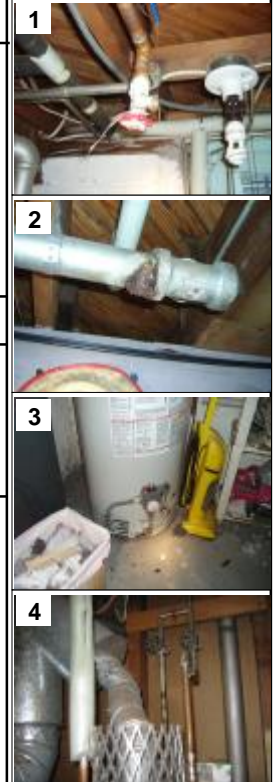
- Two active leaks were found at pipes at ceiling of basement. One leak was to the right of the boiler and the other was above the washer/dryer. Have repaired by a plumber. - (See Photos 1 & 2)
- A slow drip at water heater drain valve noted. Have repaired by a plumber. - (See Photo 3)
- The water heater has no jumper cable between the hot and cold water piping. Add electrical jumper cable for proper bonding. - (See Photo 4)
