# Residential Property Inspection

Demo Report · Las Vegas, NV 89119

**Oct 25, 2025 12:00 PM**

**Premium Home Inspections Inc.**

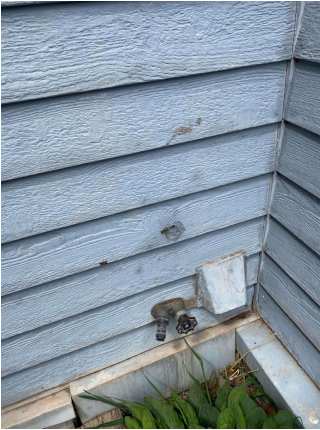
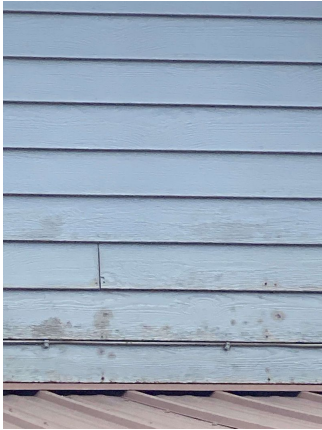
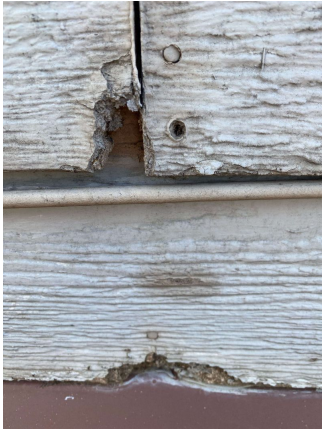
| Description | Exterior Insulation and Finishing System |
| Condition | Rotted<br>Mildew |
| Summary Labels | Major Issues |

| Recommended Action | Repair or Replace |

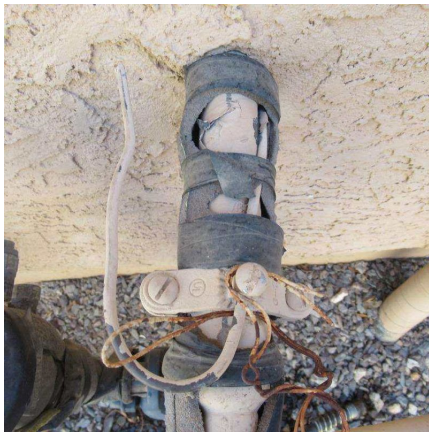
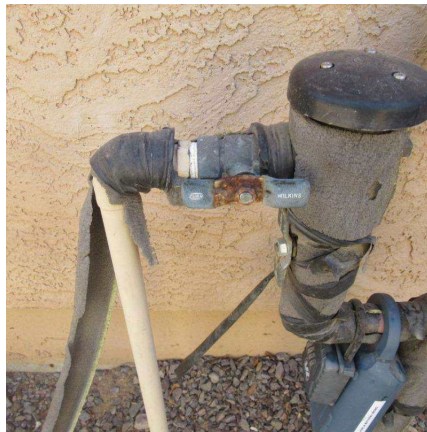
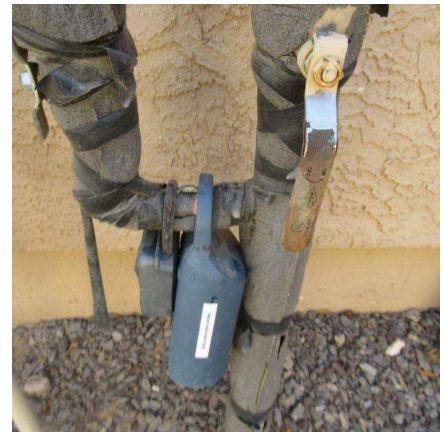
| Condition | Deteriorated insulation<br>Leaked<br>Not Frost Protected |
| Risk | Freezing during extreme weather in winter |
| Location | Exterior<br>West side |

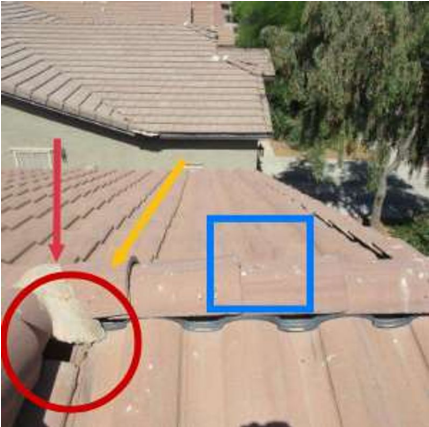
Tile slipped from original position at north center gable above garage. Repairs may be made by the homeowner or a handyman.

Image 2.2.1 - Roof tile has slid out of place - NE Corner of Hom

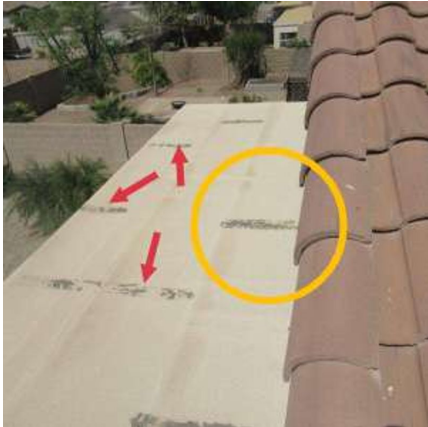
Peeling coating from roofing joints on the south patio roof.

Image 2.2.2 - Peeling coating from joints on patio roof

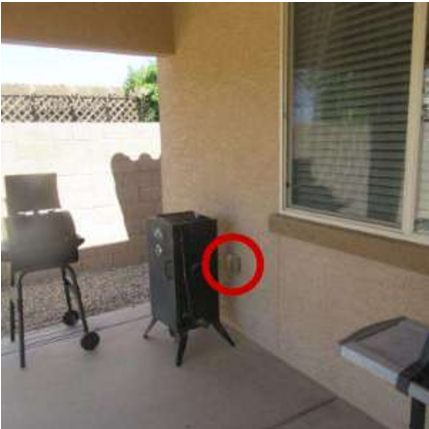
Image 3.9.1 - Broken GFCI Location

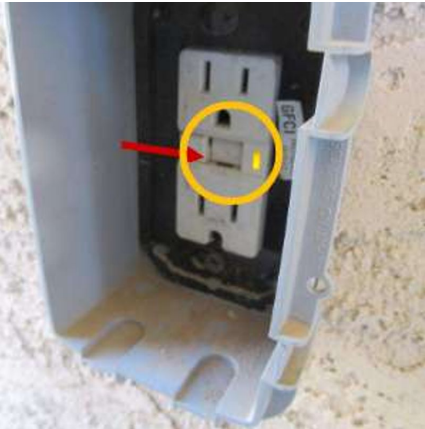
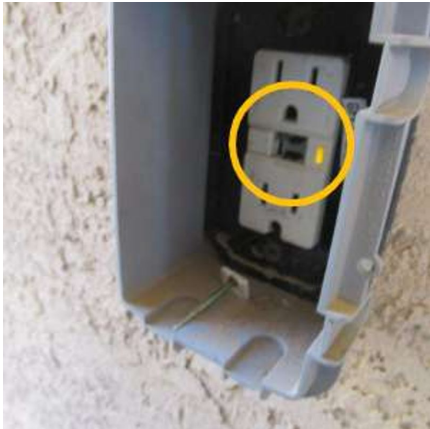
| Condition | GFCI Inoperable |
| Risk | Electrocution Hazard<br>Inoperable Outlets |

The test button on the GFCI is broken and should be repaired or replaced immediately.

Image 3.9.2 - Broken GFCI Test Button

Image 3.9.3 - Broken GFCI Test Button

| Recommended Action | Repair or Replace<br>Replacement Timeline · Immediately |

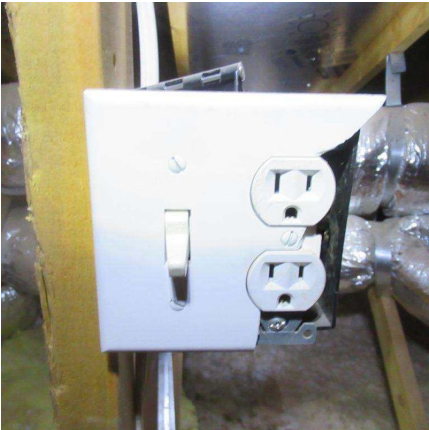
| Condition | Damaged |
| Risk | Electrocution Hazard |

Image 3.11.1 - Broken outlet cover

| Recommended Action | Repair or Replace |

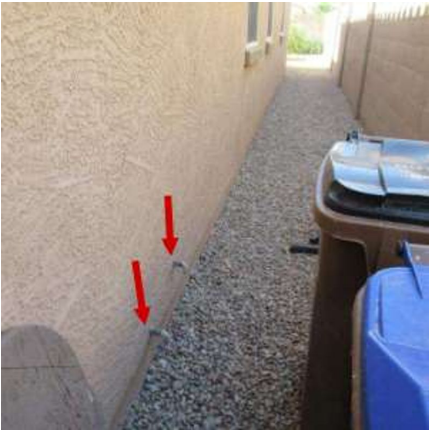
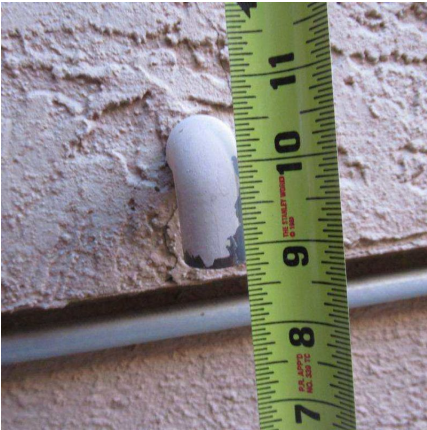
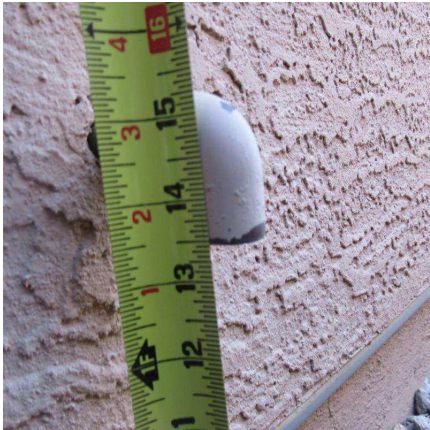
| <b>Condition</b> | Improper length |
| <b>Risk</b> | Safety concern |

Water heater discharge pipe is too short/far from ground. Steam dissipation can cause scalding to those standing nearby. Typically this should terminate 6 inches from the ground, but may vary by jurisdiction.

Image 5.4.1 - Discharge pipes on west wall

| <b>Recommended Action</b> | <b>Repair or Replace</b><br><b>Replacement Timeline</b> · Immediately |

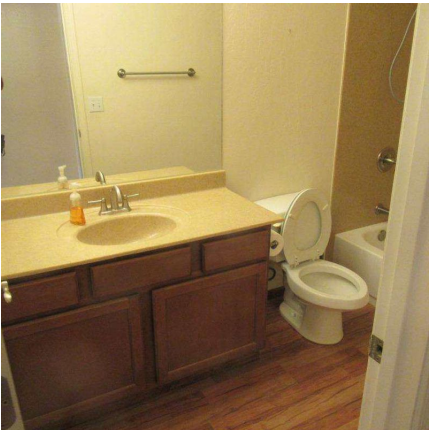
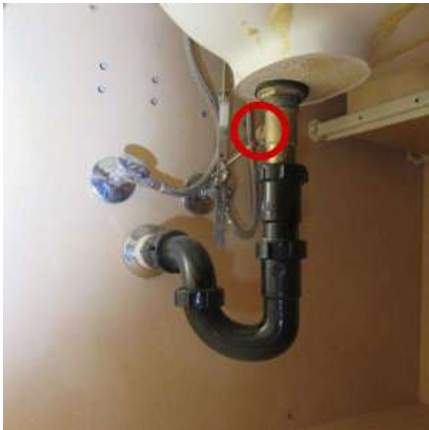
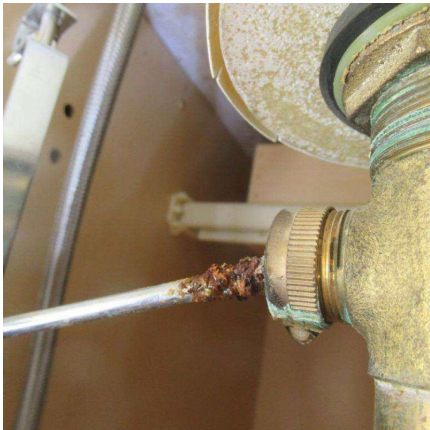
| Condition | Leaking |
| Risk | Water Damage<br>Sanitary Hazard |
| <b>Additional Notes</b><br>A leak is present at the stopper rod/drain connection. The mechanism can be dismantled to check seals for wear or cracks. | |

| Recommended Action | Repair or Replace<br>Replacement Timeline · Immediately |

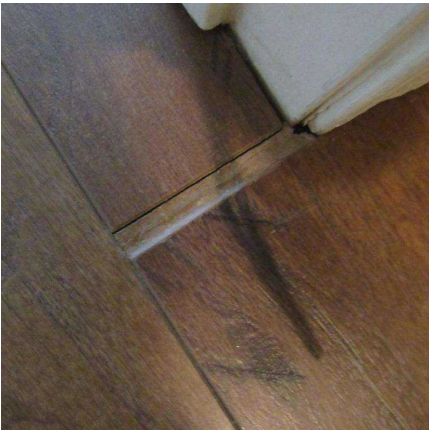
| Condition | Gap<br>Minor delamination |

Image 6.3.1 - Hardwood flooring gap - Master bedroom entry

| Recommended Action | Monitor |

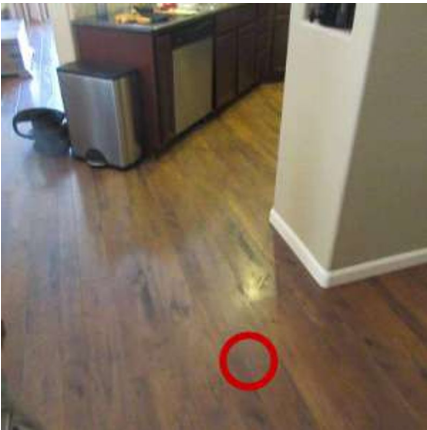
The corner of a hardwood flooring piece in the kitchen is delaminating and may get worse over time. Please monitor it at your discretion.

Image 6.3.2 - Delamination spot in kitchen

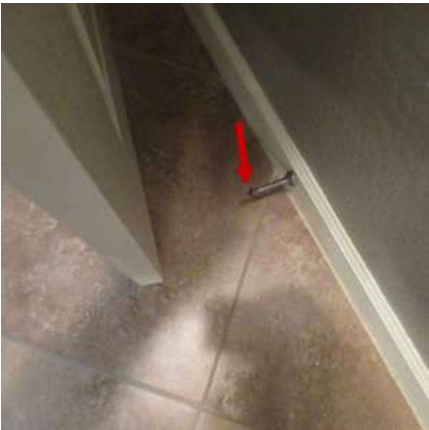
Image 6.4.1 - Laundry room

| Condition | Missing door stop bumpers |

Two of the door stops are missing the rubber bumpers that absorb the impact without denting the door. These can be purchased at your local hardware store and installed easily.

| Recommended Action | Repair or Replace |

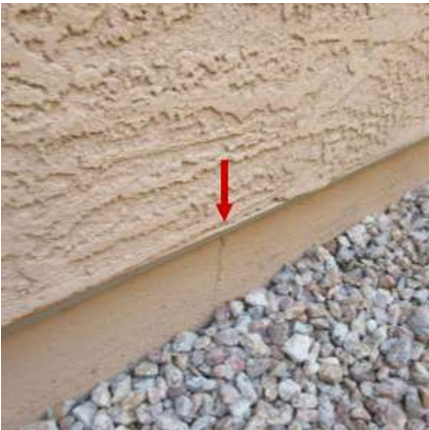
Image 7.1.1

| Condition | Hairline Cracked<br>Repaired |
| Risk | Normal settlement |

There are typical settling cracks in the foundation walls that would not need a specialist evaluation.
