# Residential Property Inspection

Demo Report · Las Vegas, NV 89119

**Oct 25, 2025 12:00 PM**

**Premium Home Inspections Inc.**

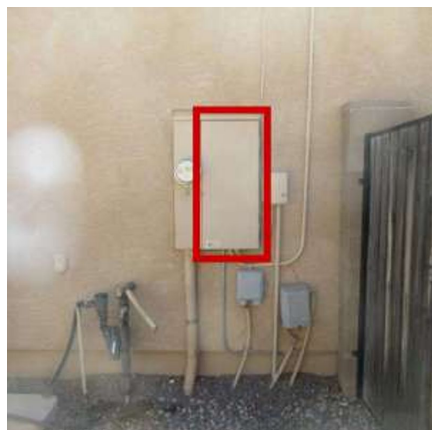
*Image 3.4.1*

Please take note of the location of the panel, as it will need to be accessed to reset breakers during home ownership.

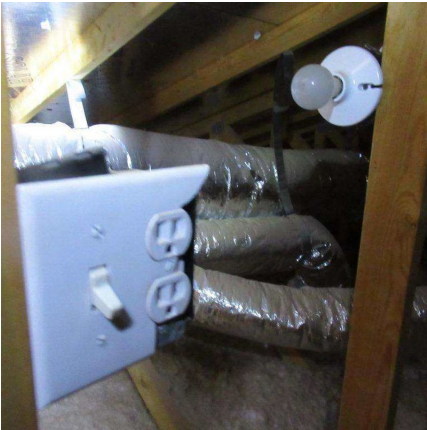
Image 3.11.2

| Condition | Damaged |

| Recommended Action | Repair or Replace |

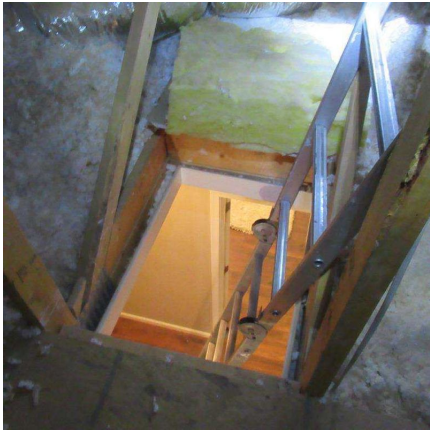
Image 3.11.3 - Entry to attic

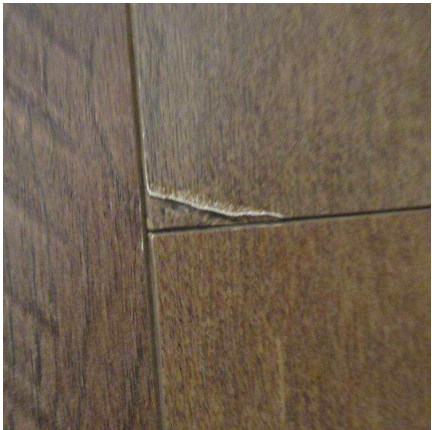
Image 6.3.3

| Condition | Gap<br>Minor delamination |

| Recommended Action | Monitor |

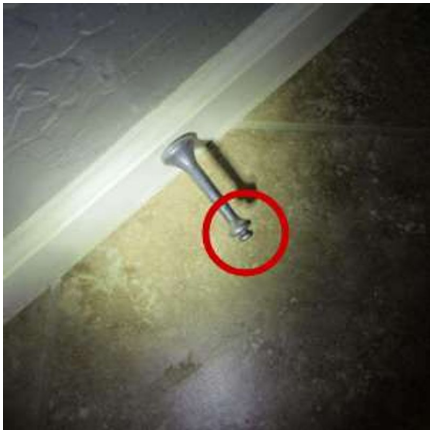
Image 6.4.3

Two of the door stops are missing the rubber bumpers that absorb the impact without denting the door. These can be purchased at your local hardware store and installed easily.

| Recommended Action | Repair or Replace |
